## EPA Releases the Explanation of Significant Difference Report for the Brunswick Wood Preserving Site

January  
2016

## Technical Assistance Report: EPA Releases the Explanation of Significant Difference for the Brunswick Wood Preserving Site

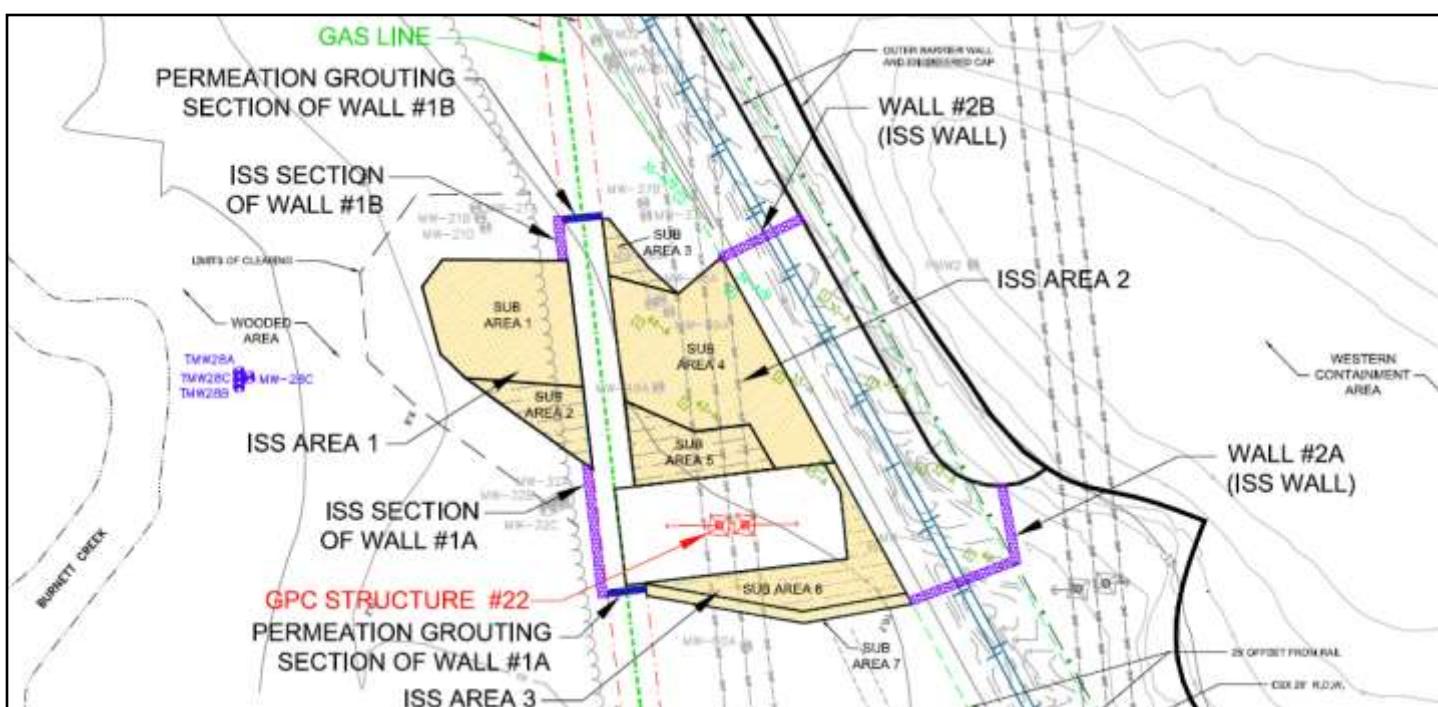
**Brunswick Wood Preserving Site map showing areas of in situ solidification**

In-situ chemical oxidation, which has been used in other areas of the site, is not being used because it cannot successfully remove the large amounts of shallow creosote present. Instead, the cleanup plan for the shallow zone includes **in-situ solidification (ISS)** which is being used to immobilize and contain the creosote outside the Western Containment Area that was not captured by the two containment walls (ISS Area 1 and 2, see map below).

Additional remedial components will be required due to the utilities and railroad tracks in that area where the creosote will remain untreated. ISS will be used again at the railroad to construct two subsurface barrier walls (Wall #2A and #2B below). At the gas pipeline, ISS and permeation grouting will be used to construct subsurface barrier walls (Walls #1A and #1B). Permeation grouting injects liquid grout into the ground to form a barrier to groundwater flow and keep the contaminants from moving. Capping will be used at the gas pipeline and the railroad tracks to keep rainwater out.

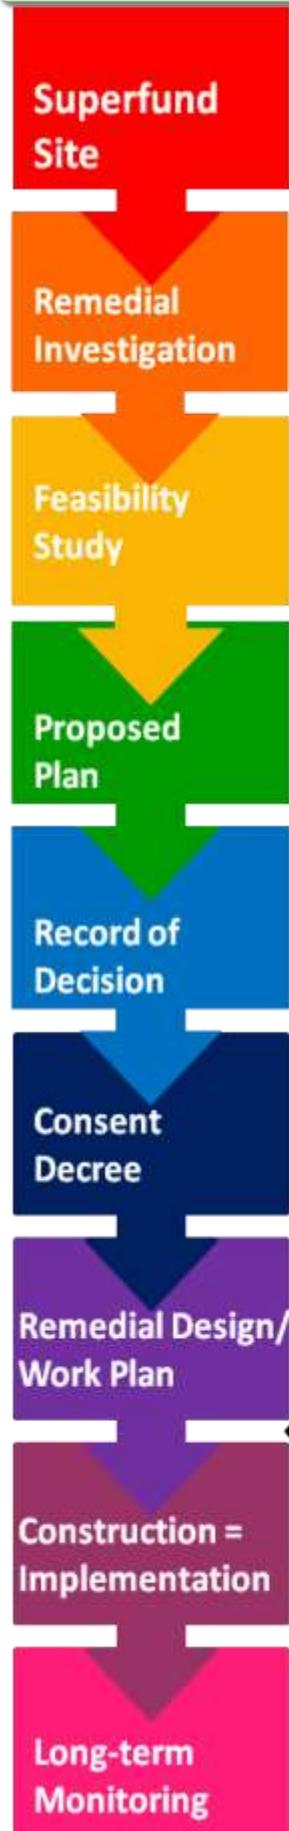
**Superfund** is the federal law to clean up contaminated sites; the process is displayed at left.

The Brunswick Wood Preserving Site is now at the **Explanation of Significant Difference** report, which is utilizing solidification/stabilization to remediate shallow creosote outside the western containment area.

★ BWP Site Is Here

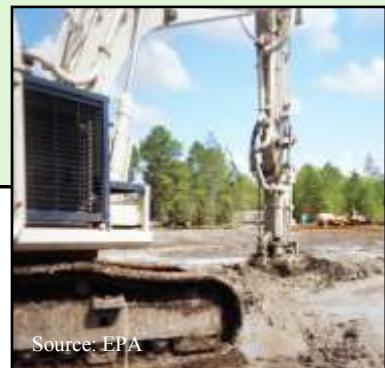
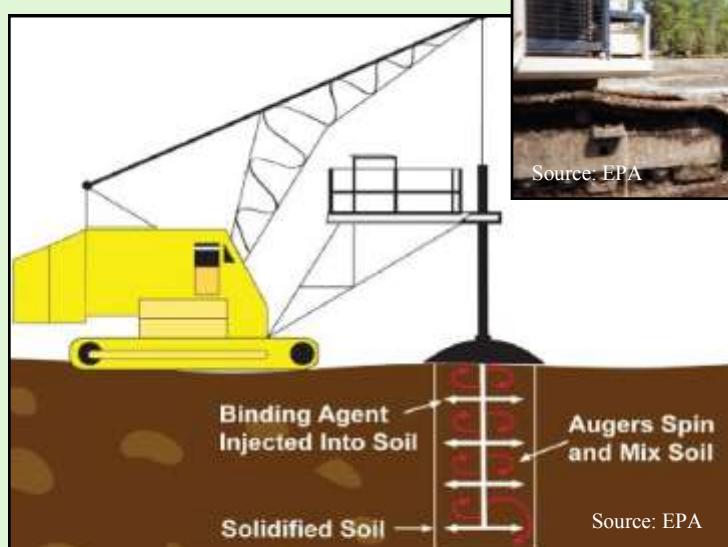
**In-situ solidification (ISS)** is a process used to bind hazardous wastes into a stable, solid block of material and trap it in place. ISS involves mixing the contaminated site soil with a binding agent that will make the loose materials stick together. The solid soil/cement mixture binds the contaminants in the soil so that they cannot move about in the ground. Using an excavator blender attachment, the cement mixture will be mixed with almost 13,000 cubic yards of contaminated soil in the Western Containment Area at the Site.

An excavator (pictured at right) and how the excavator mixes soil and a binding agent below the ground (pictured below).
