May 2020

Subsurface Contamination Defined at LCP Chemicals Superfund Site

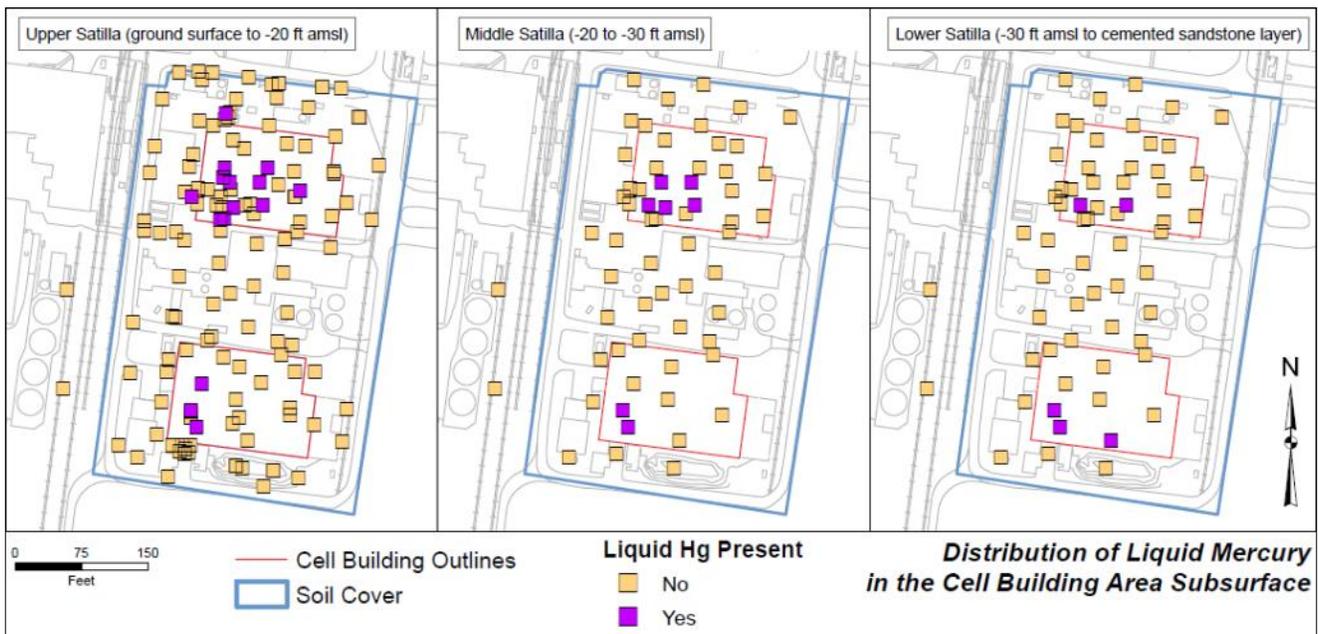
Locations of liquid mercury in soil based on visual observations. (Ref. Figure 6.1 from Site Characterization Summary Report)

Mercury that had been present in spaces beneath and between the slabs was recovered when the buildings were decommissioned. Residual mercury remains present at depth mainly to the south and east of Building No. 1. Small discrete droplets or beads of mercury were observed in many soil cores, and they were found only in sands. In the subsidence area, discrete droplets were observed up to 50 feet below ground. The beads of mercury were very small, ranging up to 2 millimeters in size. Some mercury bead “stringers” were observed; they are described as small localized deposits of beads ranging from less than 1 to 3 inches thick, in circular to elliptical shapes, with widths up to 3 or 4 times their height. The stringers were found typically resting upon clay layers.
